MONHEGAN ISLAND WHARF

PRELIMINARY DESIGN REPORT

**MONHEGAN ISLAND WHARF**

JULY 1988

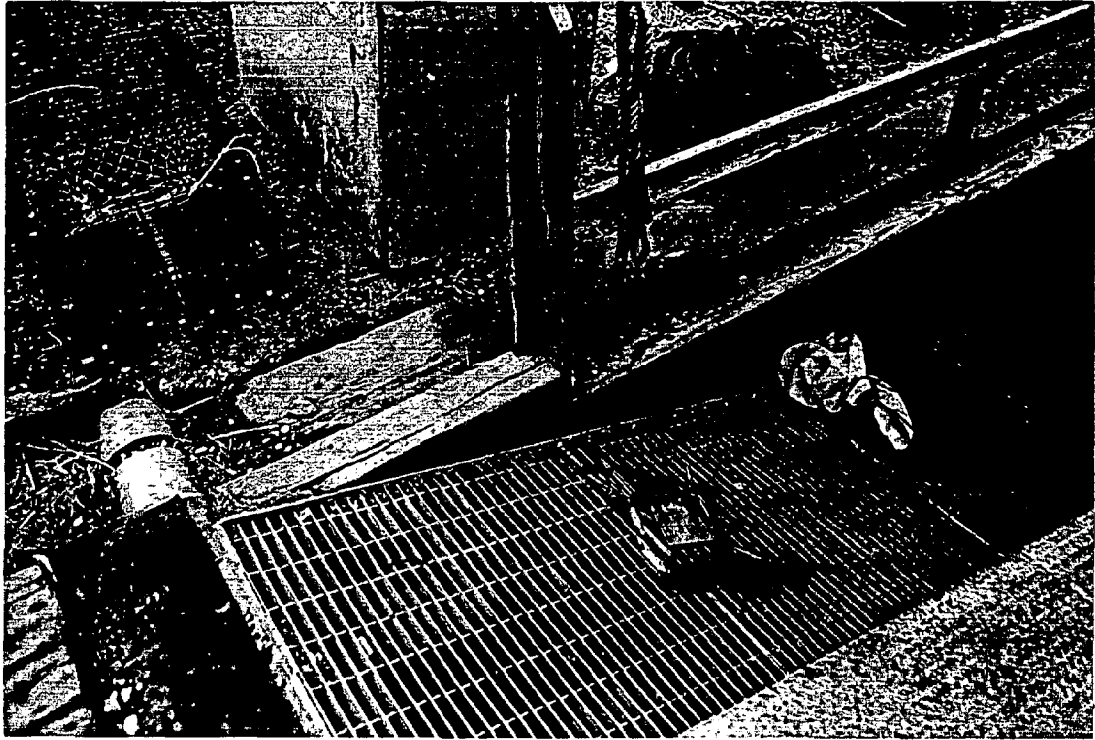
Ramp – hinge end

The wharf slip (see Figure 2) or loading/unloading ramp is a 7'x30' aluminum platform hinged on the east end and supported on the west end by cables attached to a counter weight and to chain falls. The chain falls are operated by a manually powered pulley and chain mechanism connected to a continuous loop pull chain (see Figures 12 & 13 for photographs.) The counterweight, chain falls and operating mechanism are supported by a timber frame. The operating mechanism requires considerable effort to raise the ramp as it is worn and frequently slips and jams. Chain falls are not designed to be reliable enough to support structures carrying people. Although no problems have been reported, other lifting methods would be more desirable. The timber frame has considerable dry rot. We recommend replacement of the entire wharf slip operating system, including supporting framework.

Railing along the sides of the slip should be replaced at the time the slip mechanism is replaced to bring it up to height and strength standards.
